# Structural and Corrosion Performance of Continuous Galvanized Rebar (CGR)

Anil Patnaik, PhD  
Professor and Associate Chair  
Department of Civil Engineering  
The University of Akron  
Akron, OH 44325

GalvaBar  
5101 Bird Creek Avenue  
Port of Catoosa, OK 74015  
January 2019

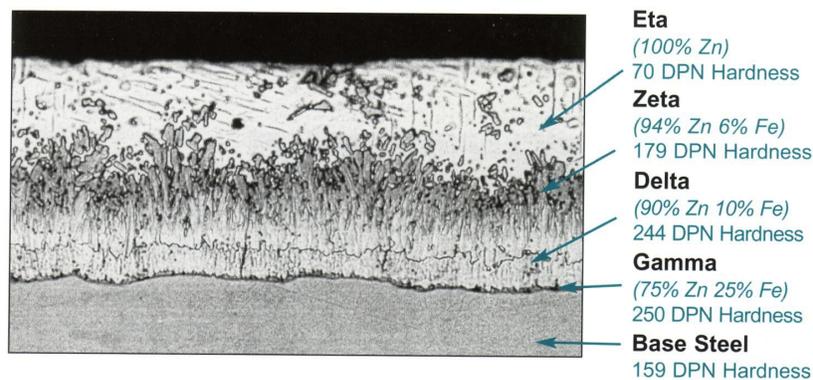
Figure 1 Typical Coating Structure of HDG Steel (Source: Yeomans, 2018<sup>2</sup>)

In traditional HDG, the surfaces of pre-fabricated steel with straight lengths, bends and/or welds are cleaned using any cleaning process that allows the zinc to bond with steel. The clean reinforcing bars or pre-fabricated reinforcement cages are then immersed into a molten bath of zinc at about 840° F (450° C) until the zinc reacts with the steel surface to form zinc-iron intermetallic alloys. The immersed steel reaches the temperature of the molten zinc within the zinc bath and metallurgical reaction takes place resulting in a series of zinc-iron alloy layers as seen in Figure 1.<sup>2</sup> These zinc-iron alloy layers grow from the steel-zinc interface while the outermost layer remains as a pure zinc layer (Eta).

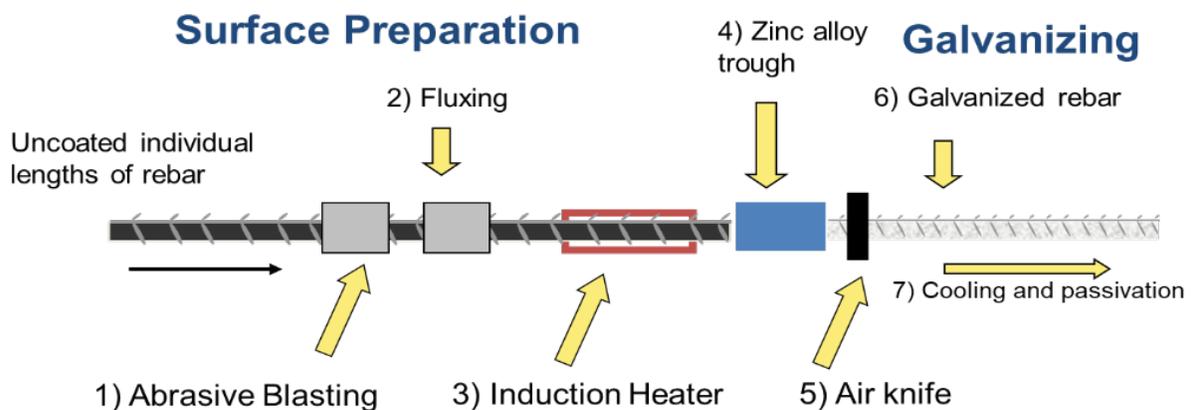
Figure 2 Continuous Galvanizing Process for Rebar (Source: Coating Controls)<sup>7,8</sup>

The continuous galvanizing process is a simple and continuous coating process for straight and coil products with advantages in terms of speed and economy resulting from reduced use of zinc as well as a reduced need for energy for heating.

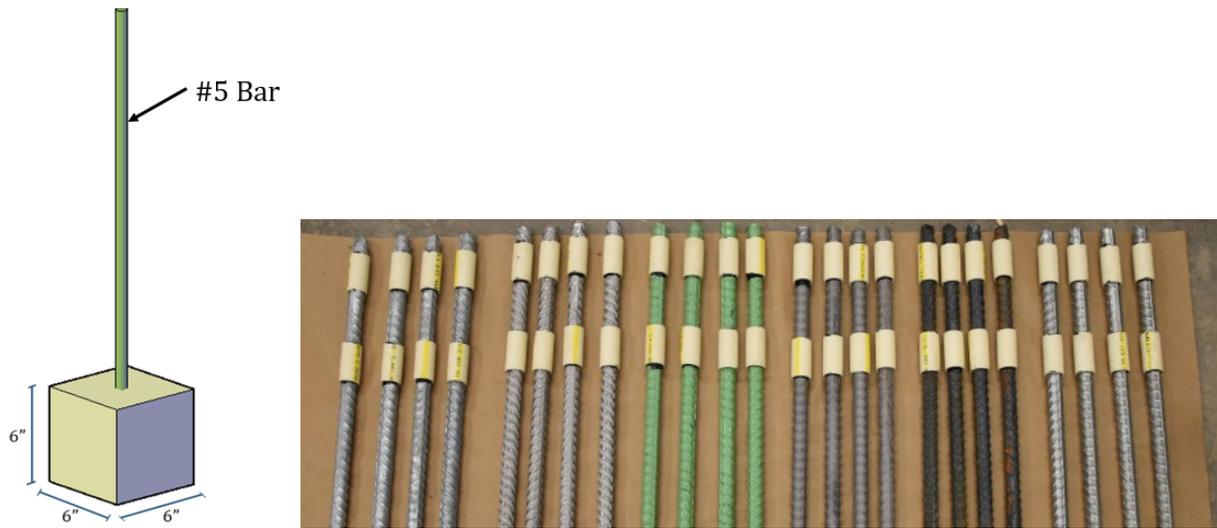
Figure 3 Pullout Specimen Details (Left) and Bar Types (Right)

Pull-out tests were conducted using prism specimens under identical conditions for different types of corrosion resistant bars with/without corrosion; and with/without 10 lb/yd<sup>3</sup> polypropylene fiber.

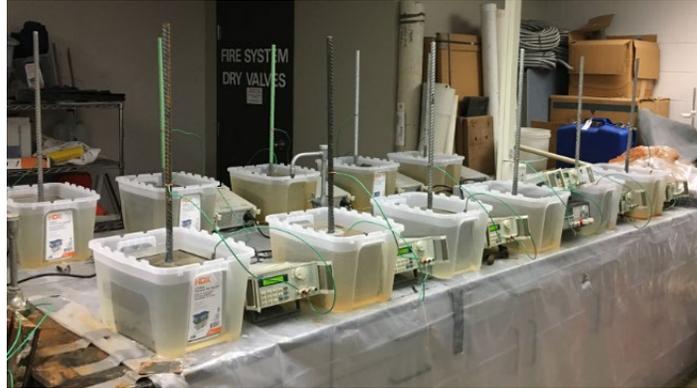
Figure 4 Test Setup of Pullout Specimens Subjected to Accelerated Corrosion

Of the 48 specimens mentioned in Table 3, a total of 24 specimens were subjected to accelerated corrosion for a period of 10 days. Five percent corrosion level was used as a basis and the current intensity was calculated using Faraday's equation. An impressed current of 0.02 A was applied to the bars; a specially made casing using stainless steel plates was used as the cathode. A 5% NaCl solution was used as electrolyte in a plastic tank, in which the specimens were immersed until the solution just reached the top surface. A two-day wetting and one day drying cycle was used to increase the effect of corrosion. A typical test setup for the corrosion process is shown in Figure 4. Both corroded and non-corroded specimens were tested for pullout strength using a Baldwin universal testing machine with a capacity of 300 kips.

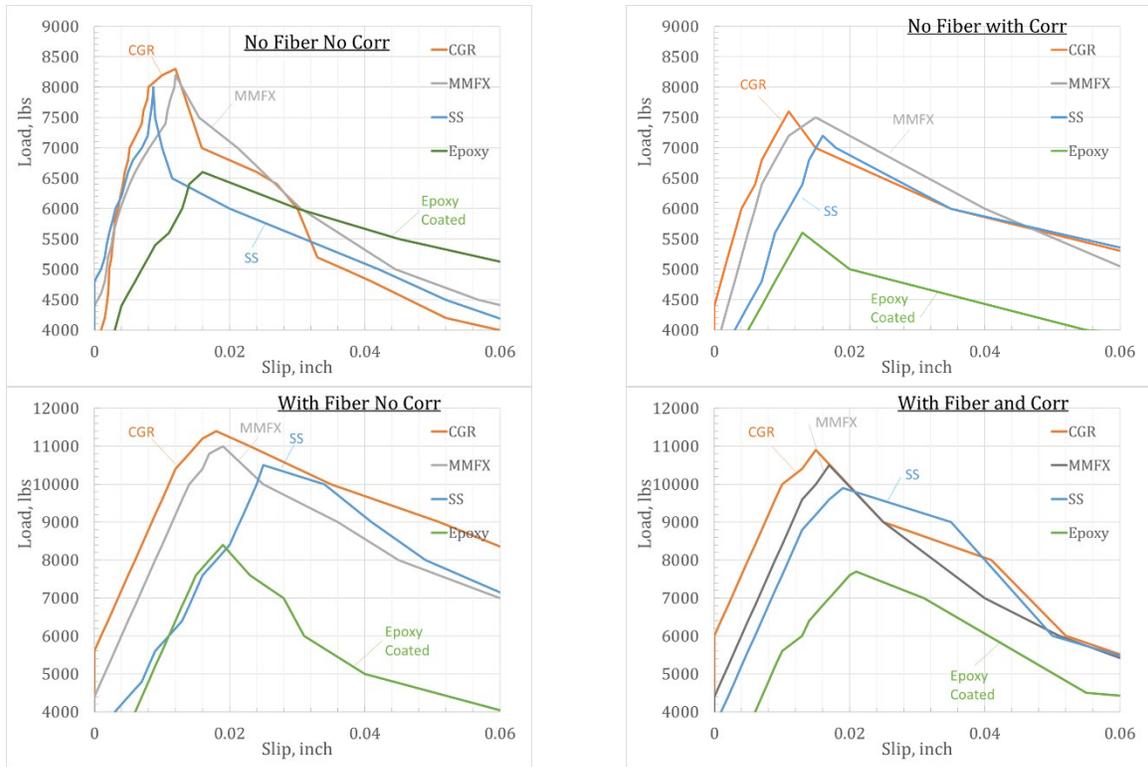
Figure 5 Comparison of Load-slip Curves of CGR with Those for Other Corrosion-Resistant Bars

Load versus slip plots obtained from pull-out tests are compared with those for CGR in Figure 5 for common corrosion-resistant bars (CGR, MMFX, SS, and ECB) and in Figure 6 for common bars (black bars, ECB). In summary,

1. CGR out-performed all other types of bars tested in this study for both corroded and uncorroded conditions, with and without fiber.
2. CGR out-performed all the corrosion-resistant steel bars, and its performance was:
  - Better than ECB by a large margin
  - Clearly better than stainless steel bars
  - Relatively better than MMFX.
3. Addition of fiber to the concrete improved the performance of CGR (as with other bars) by at least 10 to 15%, both in corroded and uncorroded conditions.
4. From these test results, it is evident that CGR will provide better structural and corrosion performance in reinforced concrete than the other bars tested in the study.

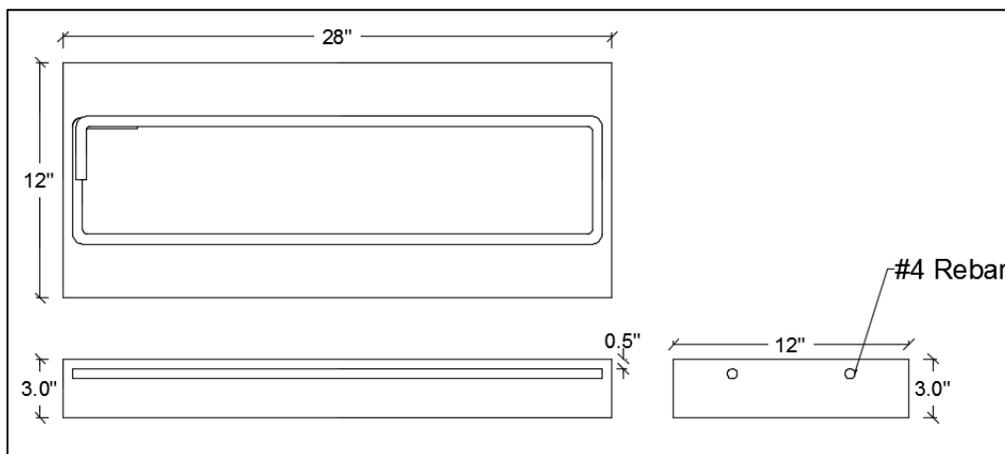
Figure 7 Schematic of the Slab Specimen Designed for Corrosion Testing

Eighty slab specimens were made with dimensions shown in Figure 7 using conventional black bar as well as several types of corrosion-resistant reinforcing bars (epoxy-coated bars, hot-dipped galvanized bars, stainless steel bars, and MMFX bars). These slabs were cast using typical 4,500 psi concrete with and without polypropylene fiber dosage of 10 lb/yd<sup>3</sup>.

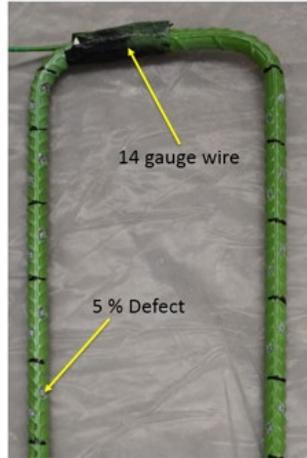
Figure 8 Wire and Defects Applied to the Epoxy-Coated Bars

For specimens made using epoxy-coated steel bars, a 5% defect on the surface area of the coating was induced on the bars in order to initiate corrosion and replicate corrosion damage that can occur on site during the handling process. Figure 8 shows an epoxy-coated steel bar with manually applied defects. A 5% defect was introduced so as to induce corrosion damage rapidly. It was found that the final corrosion damage was similar in nature regardless of the defect size (2.5% or 5%). However, a 5% defect induces corrosion damage within a shorter duration of exposure.

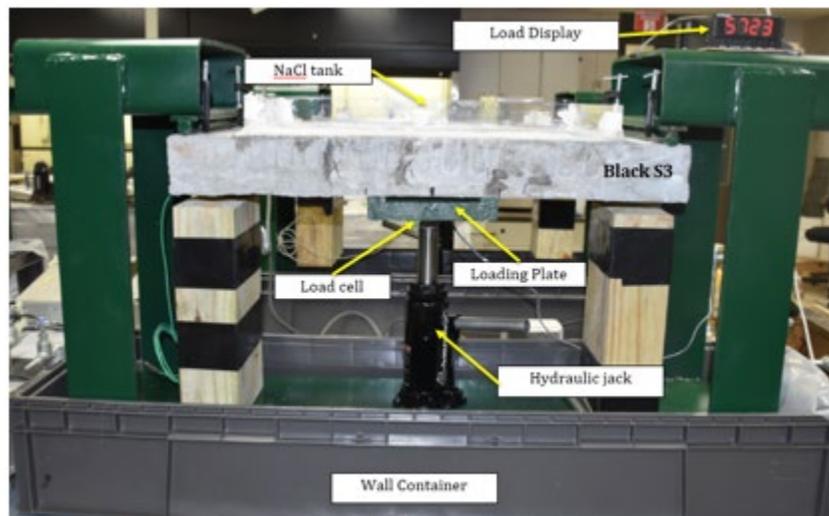
Figure 9 Typical Setup of Corrosion Tests for Slabs

The test setup for the corrosion testing was designed to replicate the actual conditions observed on bridge decks. Each slab was supported in a specially fabricated test frame, and a constant sustained load was applied to the slab using a hydraulic jack. A salt solution tank was attached to the tension face of the slab. A stainless steel plate was used to act as a cathode. Figure 9 shows the test setup for the accelerated corrosion of a typical test slab.

A 10-kip load cell having a digital display was used with each hydraulic jack to continuously monitor the load applied on the test slab. A sustained load of 4.2 kips (i.e. 40% of the failure load of the slab) was maintained throughout the corrosion process. The applied load level was selected to replicate the dead load stresses that constantly act on bridge decks.

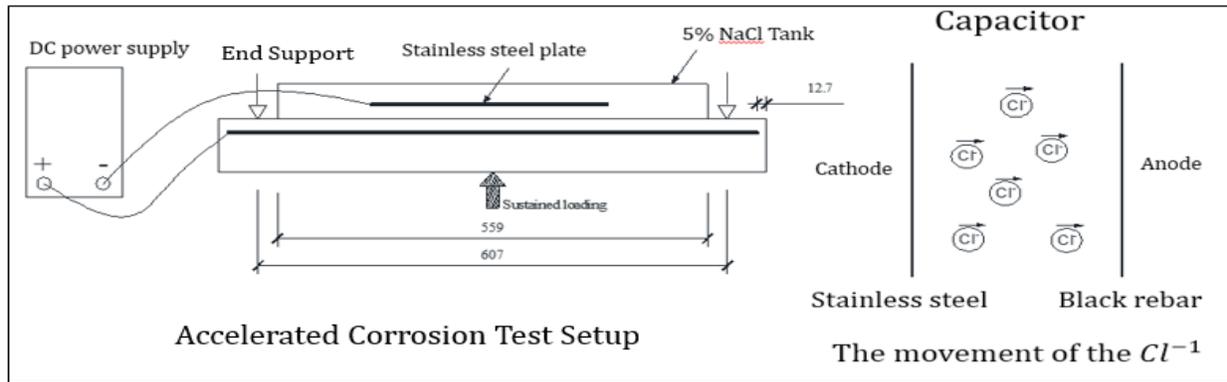
Figure 10 Schematic of the Corrosion Test Setup

where  $\Delta m$  is the mass of steel consumed (grams);  $M$  is the atomic weight of the metal (56 grams or 0.1232 lb for Fe);  $I$  is the current (amperes);  $t$  is time (seconds);  $z$  is the ionic charge (which is equal to 2); and  $F$  is Faraday's constant (96,500 amperes/second). A theoretical corrosion level of 15% was achieved over 21 days. The corrosion setup used in this study is shown in Figure 10 and Figure 11.

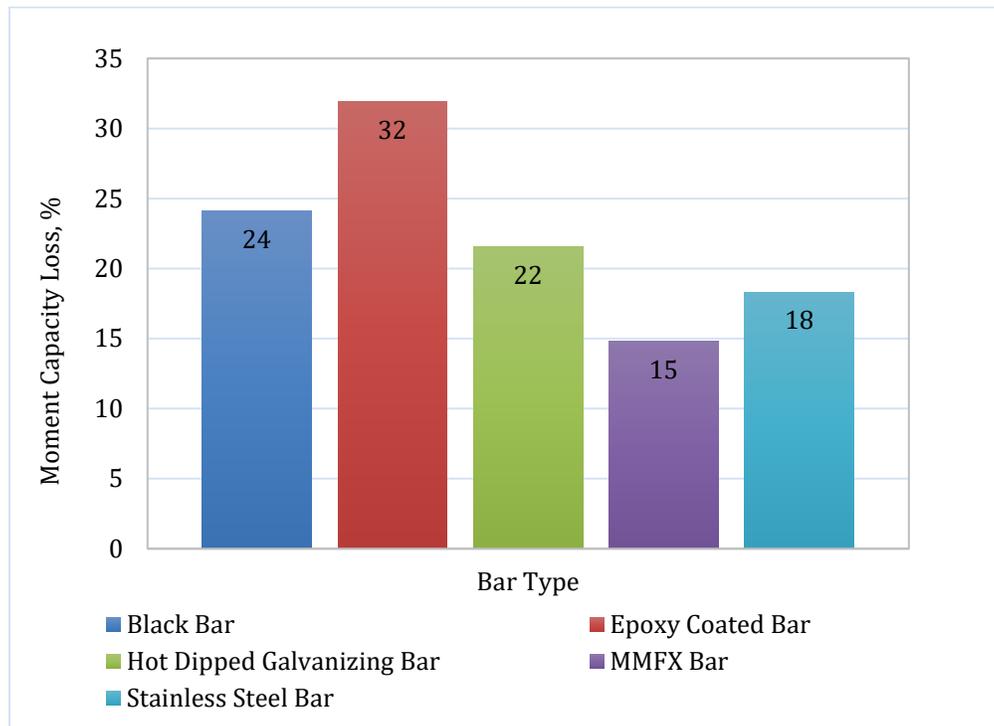
Figure 12 Flexural Capacity Loss Due to Corrosion of Specimens with no Fiber

Figures 12 and 13 present charts showing the flexural capacity test results of slabs with no fiber and with fiber, respectively. As can be seen in Figure 12, epoxy-coated bars with 5% damage induced on the coating showed the largest extent of corrosion compared to the other bar types, in terms of maximum flexural capacity loss due to loss in bond and reduced area of steel. MMFX bars showed the best corrosion resistance and the lowest loss of pull-out strength. In hot-dip galvanized bars, the zinc coating protected the bar from corrosion for a few days; once the sacrificial layer was compromised, the base metal showed a similar effect as the black bars. Hence, the capacity loss for the slab with hot-dip galvanized bars is much closer to that of slabs with black bars. Slabs with stainless steel bars also showed good performance after corrosion as well as a smaller loss of flexural capacity due to corrosion.

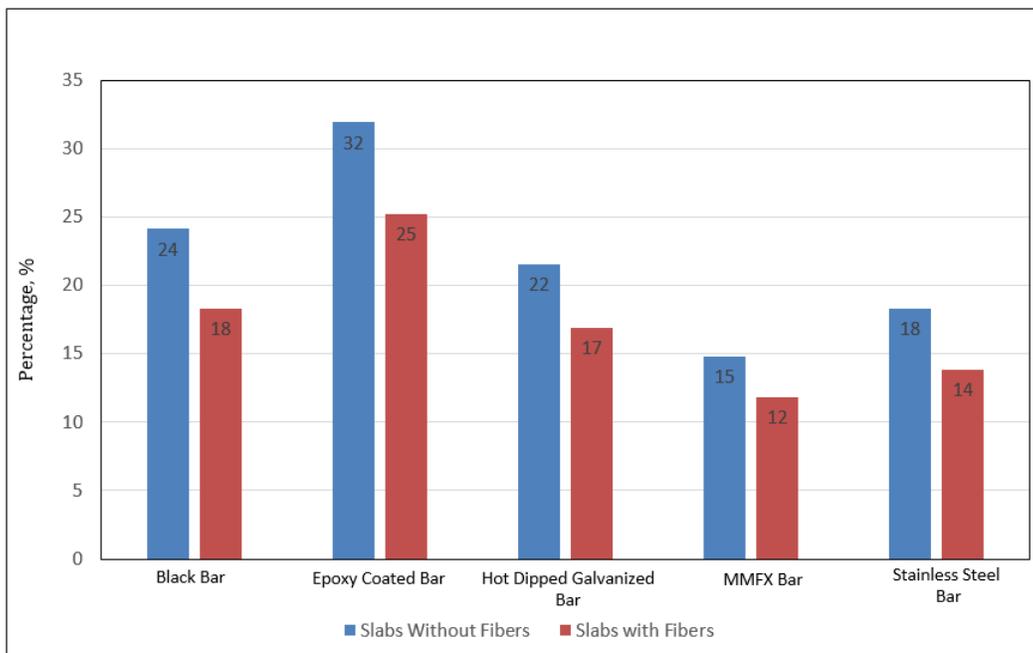
Figure 14 Percentage Reduction in Capacity Loss of Slabs with and without Fiber

Figure 14 shows the comparison of slabs with and without fiber in terms of percentage reduction in capacity loss. The performance of slabs with fiber was much better than the performance of slabs with no fiber. The trend in the percentage of capacity loss was similar to the trend of the capacity loss for slabs without fiber. Slabs made with epoxy-coated bars with a 5% induced defect showed the most moment capacity loss, and the slabs made with MMFX showed the least moment capacity loss. It can be observed that the addition of fiber results in a smaller loss of capacity, even though the slabs have undergone an accelerated corrosion process.

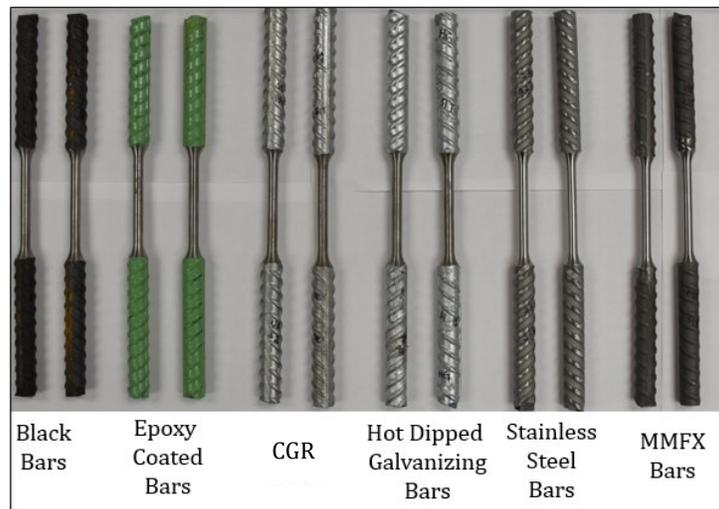
Figure 15 Various Reinforcement Bars Machined at the Center for Tensile Strength Testing

The mechanical properties of the six bar types included in this study (Figure 15 and Figure 16) were determined using ASTM E8 standards. A summary of the mechanical properties are listed in Table 6.

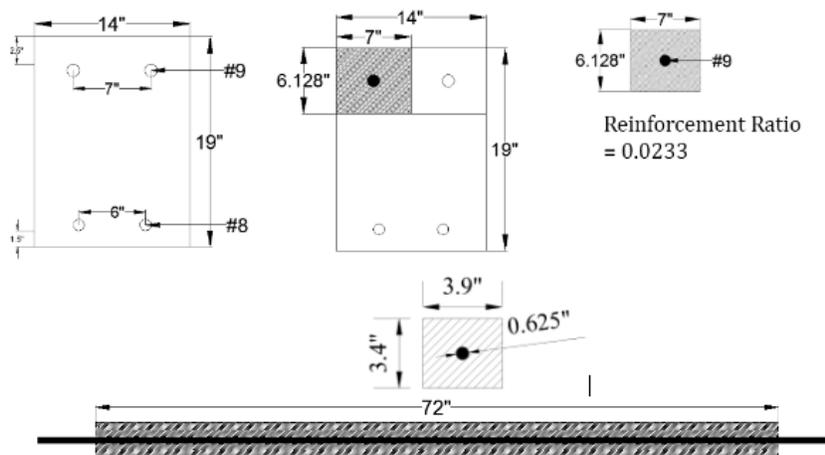
Figure 17 Sectional Details of Long Prism Specimens

Prisms specimens with a length of 90 inches were designed to maintain the same reinforcement ratio and the same ratio of the dimensions of the sides as in the tension zone surrounding the reinforcing bars in a typical bridge section. The section details of the resulting prism specimen are shown in Figure 17.

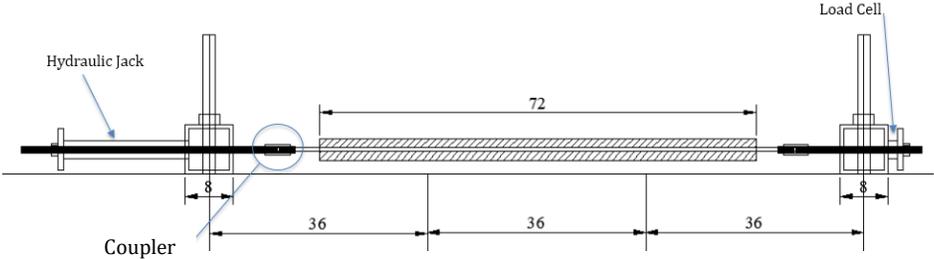
Figure 18 Test Setup for Long Prisms

The test setup was designed to apply tensile force axially as shown in Figure 18.

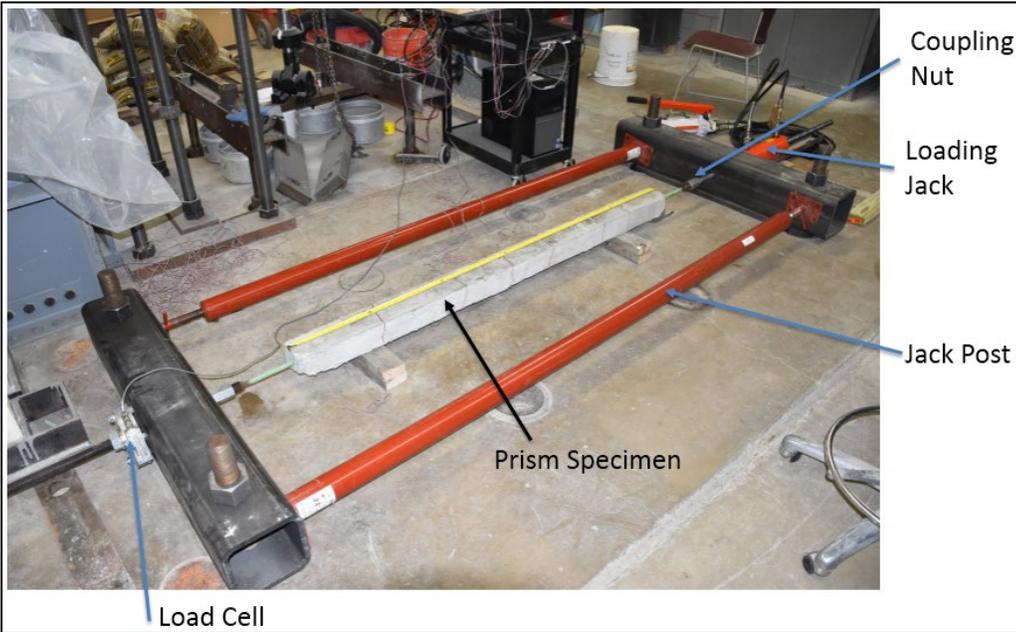
Figure 19 Test setup for Testing of Long Prisms

A total of 24 long prisms (two specimens each of six reinforcing bar types, with and without fiber) were cast with cross-sectional dimensions of 3.4”x3.9” and the reinforcement ratio of 0.0233. Specimens with and without 10 lb/yd<sup>3</sup> of polypropylene fiber were made in duplicates with (i) black bar, (ii) epoxy-coated bar, (iii) dual-coated Z-Bar, (iv) stainless steel bar, (v) hot-dipped galvanized bar, and (vi) CGR. Specimens were tested for axial direct tension cracking after 28 days. The average concrete strength was 4,800 psi on the day of testing. The typical test setup for the long specimen testing is shown in Figure 19. Crack widths were measured and recorded manually using crack gage at every 0.5 kips of load.

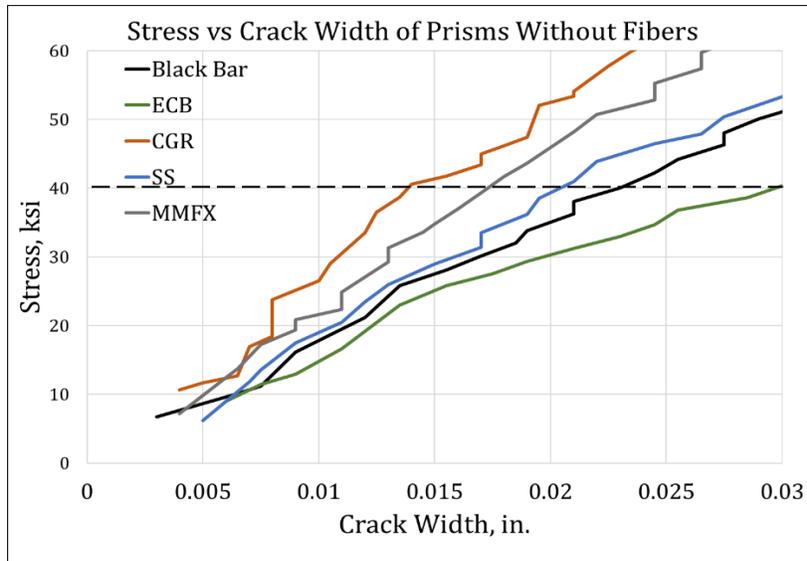
Figure 20 Comparison of Crack Widths for Prisms without Fiber

Test results for different reinforcing bars, both with no fiber and with fiber are shown in Figure 20 and Figure 21.

From the test results, it is observed that the specimens with epoxy-coated bars showed wider cracks at a given load or stress level compared to specimens with other bar types, whereas prism specimens with MMFX and CGR showed smaller crack widths. Specimens with black bars and hot-dipped galvanized bars showed similar cracking behavior. The crack widths on specimens containing fiber with epoxy-coated bars were wider compared to the specimens with other bar types, whereas specimens with MMFX and CGR bars showed smaller crack widths. The crack widths for specimens with fiber were smaller by about 25% as compared to the corresponding specimens without fiber. A comparison of crack widths for the bars tested in this study at a stress of 40 ksi is presented in Table 7. CGR bars showed consistently smaller crack widths at all loads compared to MMFX and all other bar types.

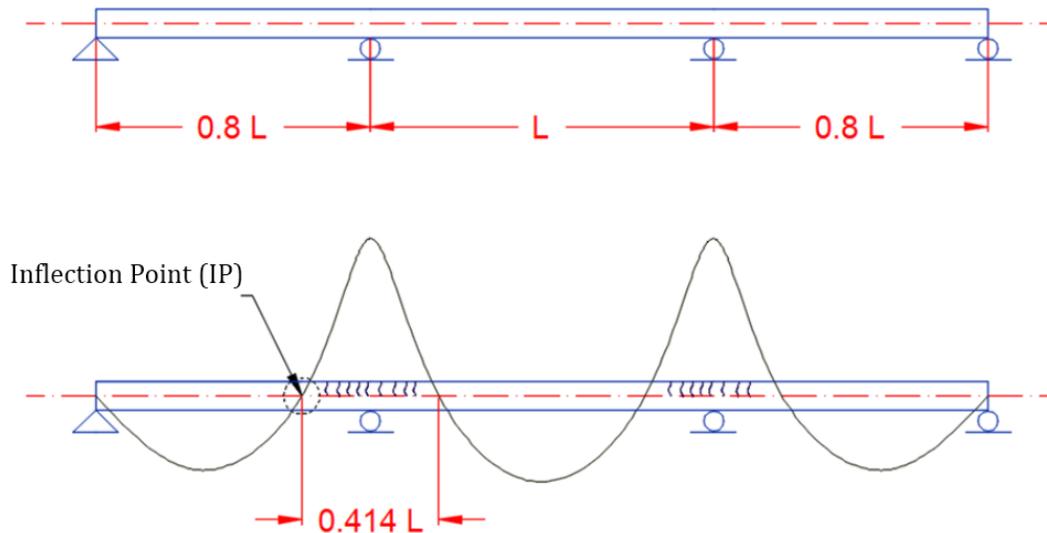
Figure 22 Bending Moment Diagram Showing Inflection Points

Typical three span continuous slab bridges are designed in such a way that the span length of exterior spans is 0.8 times of that of interior span. Figure 22 shows bending moment diagram and the inflection points for a three span continuous slab bridge subjected to uniform loading.

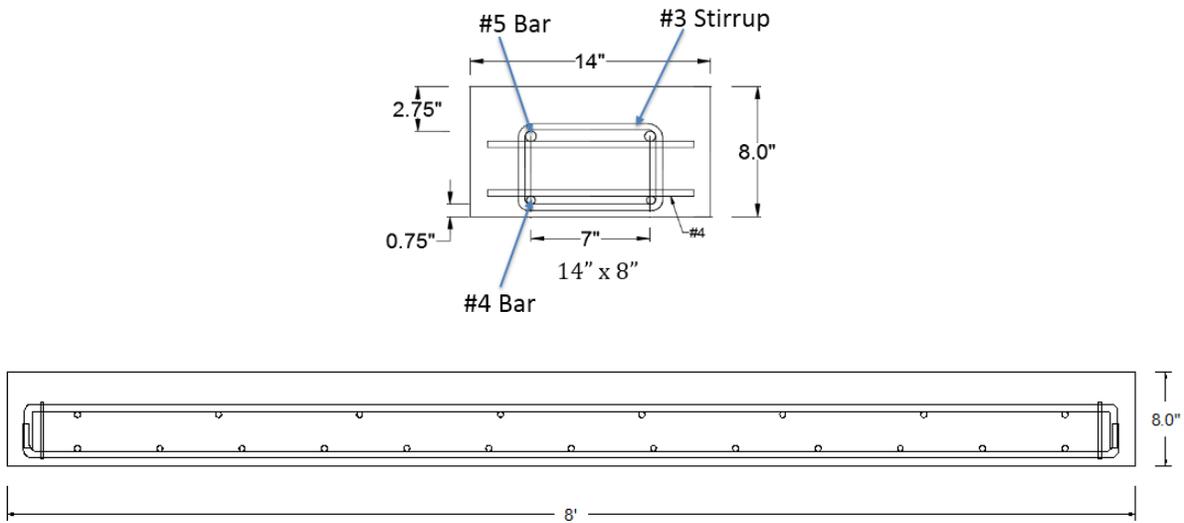
Figure 23 Test Slab Details

A typical section of test beams is shown in Figure 23. The test setup is shown in Figure 24. Six different reinforcing bar types were used on the tension side of the test slabs, with two slabs made for each bar type. A total of 24 slab specimens with and without fiber were cast to study flexural cracking. The tension steel was #5 bar of different types of reinforcement, whereas the compression steel was #4 black bar in all specimens. The applied load, stress in the bar, crack widths, and deflections were monitored and recorded continuously during the testing process. Two specimens of each bar type were tested to determine the average of two sets of results.

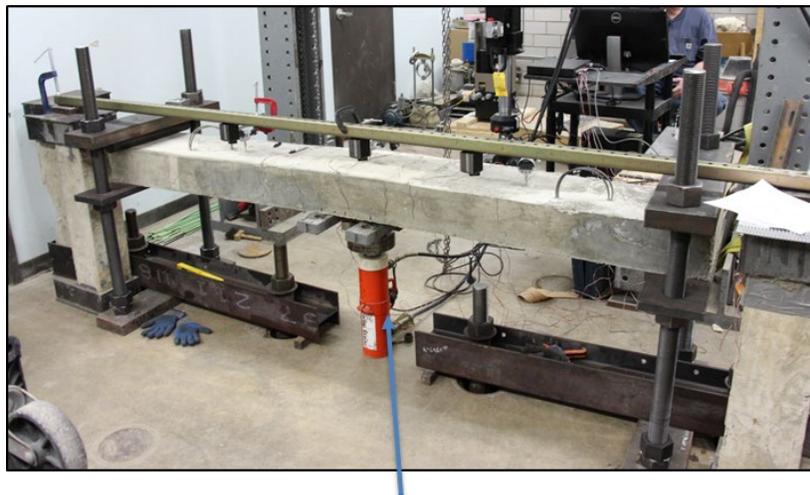
Figure 24 Test Set-up

Loading from the bottom to cause cracking at the top

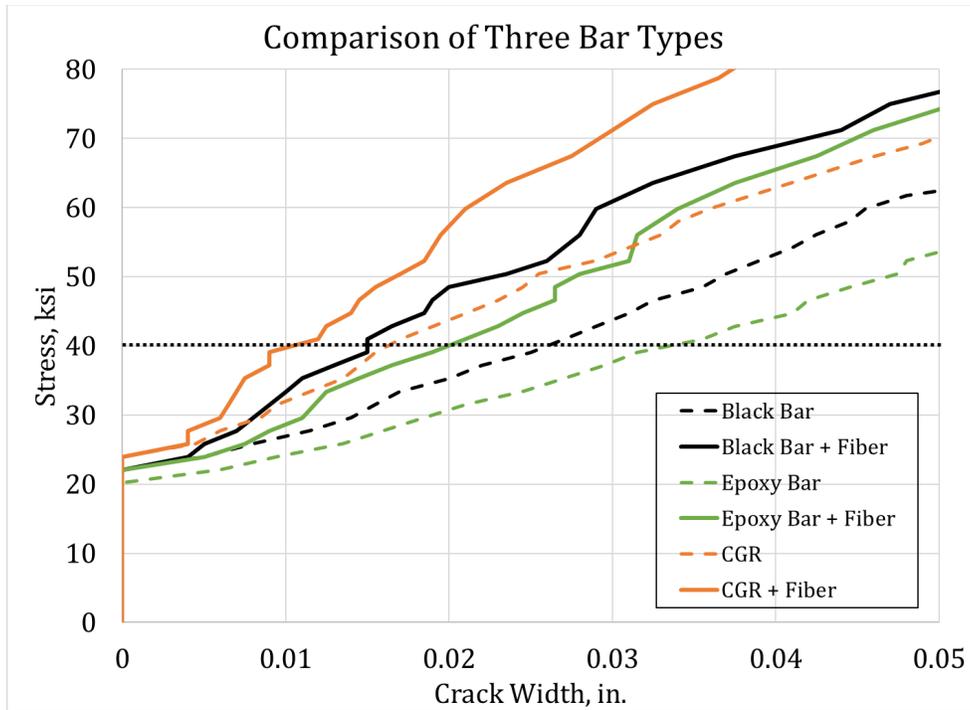
Figure 25 Comparison of Crack Widths for Slabs with and without Fiber and with Black Bars, ECB and CGR

Strains and applied loads during the test, deflections, crack spacing and crack widths were measured during the tests. The crack widths were averaged from the results of two specimens for each bar type. Figure 25 shows a comparison of stress versus crack widths for slab specimens with CGR with and without fiber and common reinforcing bars (black bars and ECB). Figure 26 and Figure 27 show similar comparisons for slab specimens with corrosion-resistant bars, both with and without fiber.

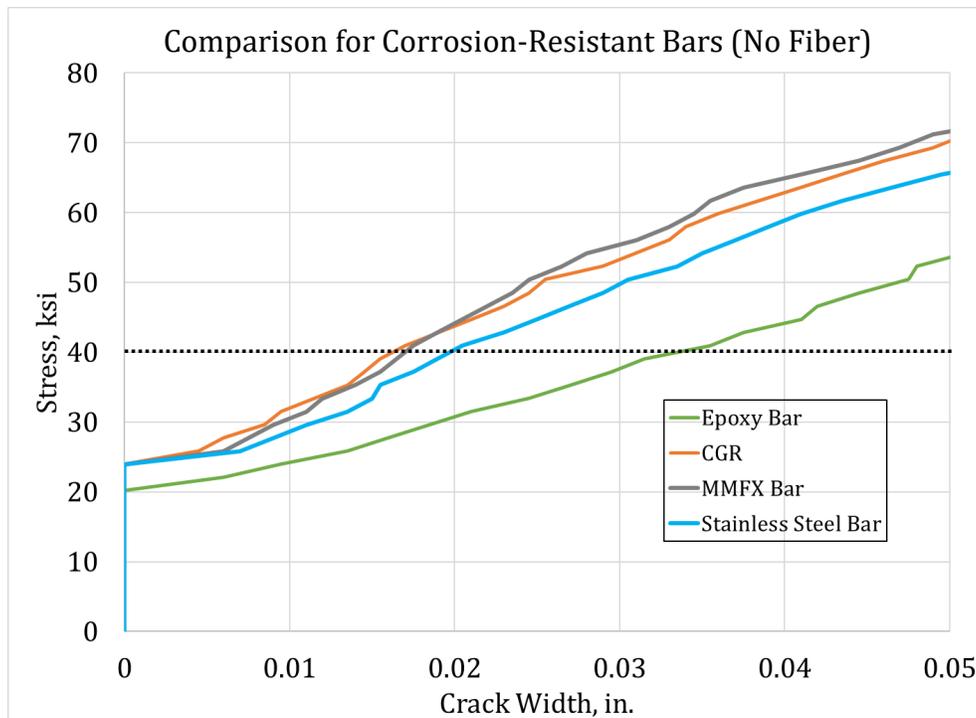
Figure 26 Stress vs. Crack Widths for Slabs with Different Bar Types (No Fiber)

In the case of slabs without fiber, the test specimens with epoxy-coated bars showed wider cracks compared to those with other bar types, whereas slabs with MMFX and CGR showed smaller crack widths. In case of slabs with fiber, a similar trend was observed, with much closer values for most bar types. The crack widths observed for slabs with and without fiber are compared at 40 ksi stress and are presented in Table 8. From the crack width data, it is clear that slabs reinforced with CGR had the smallest crack widths. The crack widths of slabs with ECB and those with black bars are significantly larger. Slabs with MMFX showed similar crack widths as those reinforced with CGR. Addition of fiber substantially reduces crack widths.

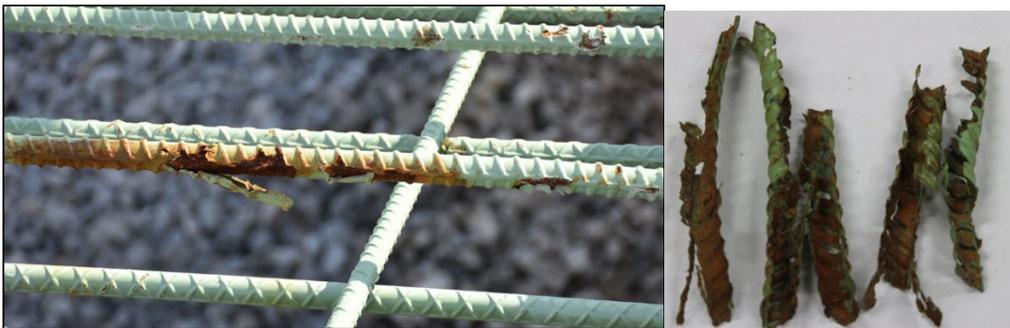
Figure 28 Condition of Epoxy Coating in a Demolished Bridge Deck after About 25 Years of Service

The polymer-based coatings on ECB are generally soft and are susceptible to scratching and damage. Peeling of the epoxy coating from the bar surface is common after the bars are subjected to corrosion (Figure 28). Because of metallurgical bonding of zinc with steel, CGR has a tough and scratch-resistant coating and a zinc-steel interface that is well bonded.

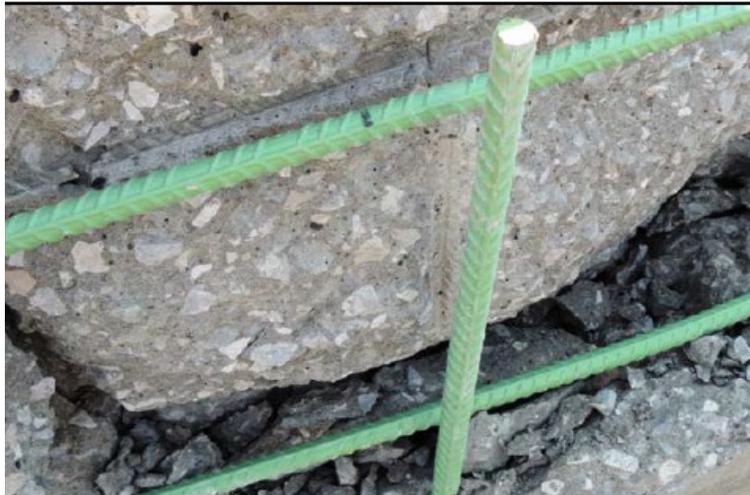
Figure 30 Lack of Bond Between Epoxy-Coated Bars and Concrete Under Impact Loading<sup>11</sup>

30 shows the crumbling of the concrete surrounding an epoxy-coated bar under impact loading. This type of deficiency is more serious for larger thicknesses of epoxy coating. Dual-coated reinforcing bars are also similarly disadvantaged.

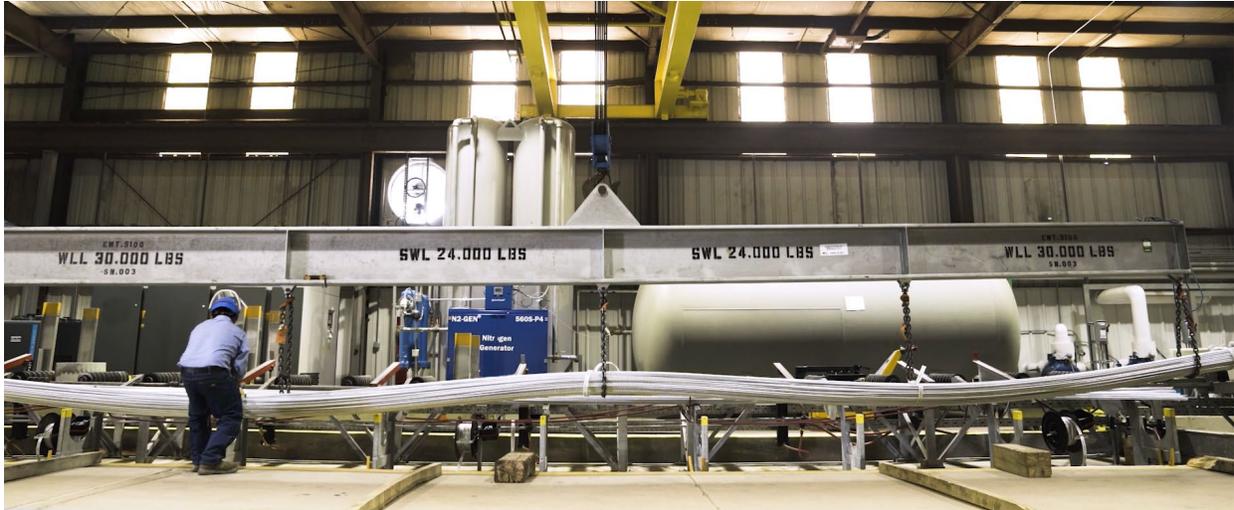
Figure 31 GalvaBar Production Facility in Oklahoma, USA<sup>7</sup>

In the United States, a plant in Oklahoma produces GalvaBar™ using a continuous galvanizing process. This plant (Figure 31) uses a highly automated, proprietary process to produce CGR at significant cost efficiencies, including lower material and labor costs. The GalvaBar production process at this plant can be applied to many grades of steel, providing a consistent coating with no risk of embrittlement. GalvaBar complies with the requirements of ASTM A1094/1094M-16 for continuous hot-dip galvanized steel bars and concrete reinforcement. Further details of GalvaBar are available on the CMC website.<sup>6</sup>

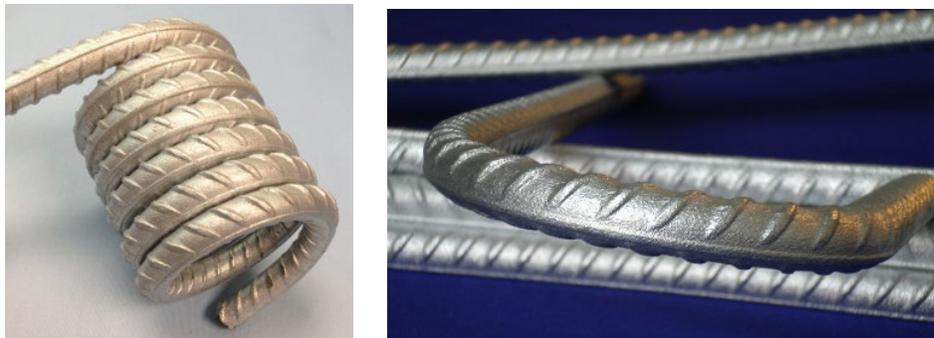
Figure 32 Bendability of GalvaBar

GalvaBar is a galvanized rebar with specialized thin zinc alloy coating that provides the well-known corrosion protection of zinc and the added benefit of exceptional formability. GalvaBar can be bent, twisted, or stretched after galvanizing without cracking, peeling or flaking. Two examples of CGR bends are shown in Figure 32. The material specifications, frequently asked questions and the guidelines for construction practices for GalvaBar (as posted on the CMC website<sup>7</sup>) are included in the appendix at the end of this report.

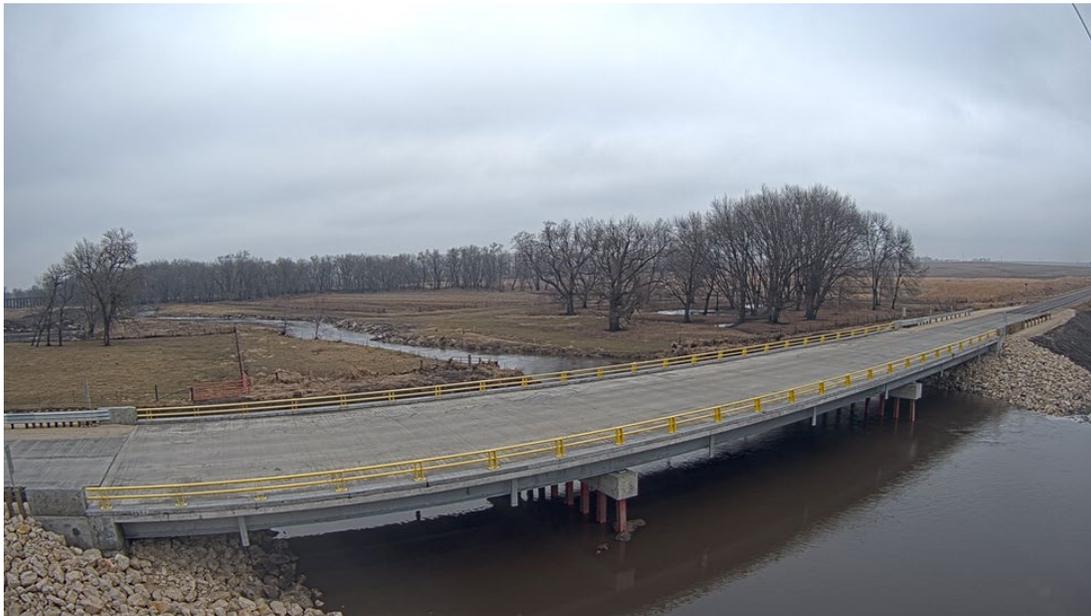
GalvaBar has been used in a project in Iowa for the Buffalo Creek Bridge in Independence, Iowa, with a 200' deck (Figure 33). The abutments and parapets utilized continuous galvanized GalvaBar. GalvaBar was also supplied for the Coffee Creek Wastewater Treatment Plant in Edmund, Oklahoma. GalvaBar is being used for many balconies, seawalls and foundation projects in Florida. GalvaBar has been shipped as far as Bahamas and can also be purchased from Menards home improvement centers.

Figure 33 Buffalo Creek Bridge in Independence, Iowa  
GalvaBar was used in the Abutments and Parapets of this Bridge
